# Mobile Intel® Celeron® Processor on .13 Micron Process in Micro-FCPGA Package

Specification Update

Document Number: 251309-013

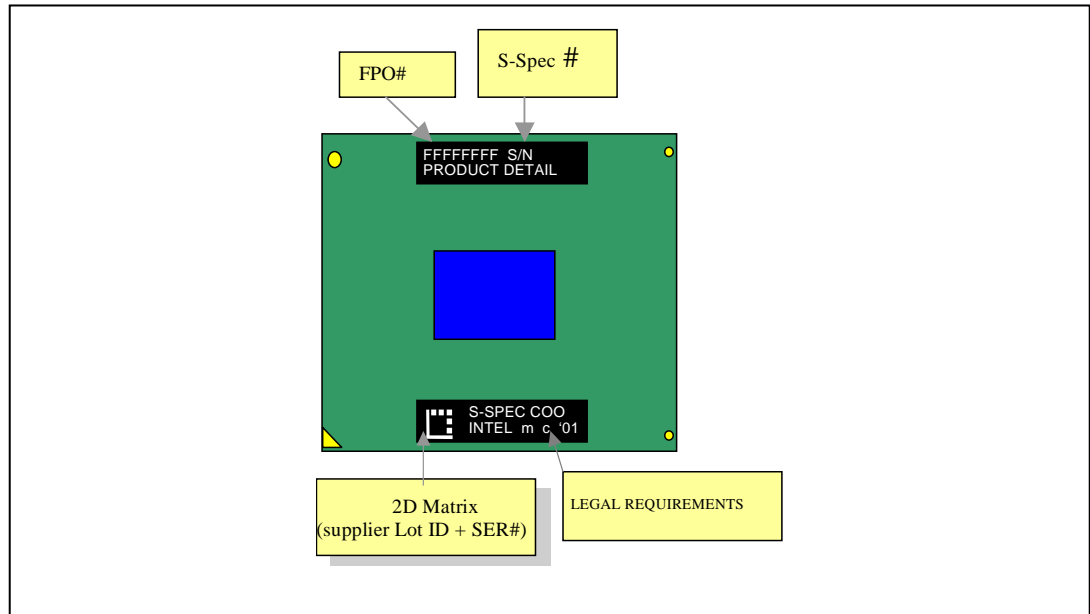
Figure 1. Mobile Intel® Celeron® Processor on .13 Micron Process (Micro-FCPGA) Markings
